Structural Report

Redundant Railway Bridge Abutment Adjacent to Lucy Plackett Playing Field, Adderbury

Sketch SK/01A - Plans, Elevations and Details Showing Structural Defects – Updated Jan 2026

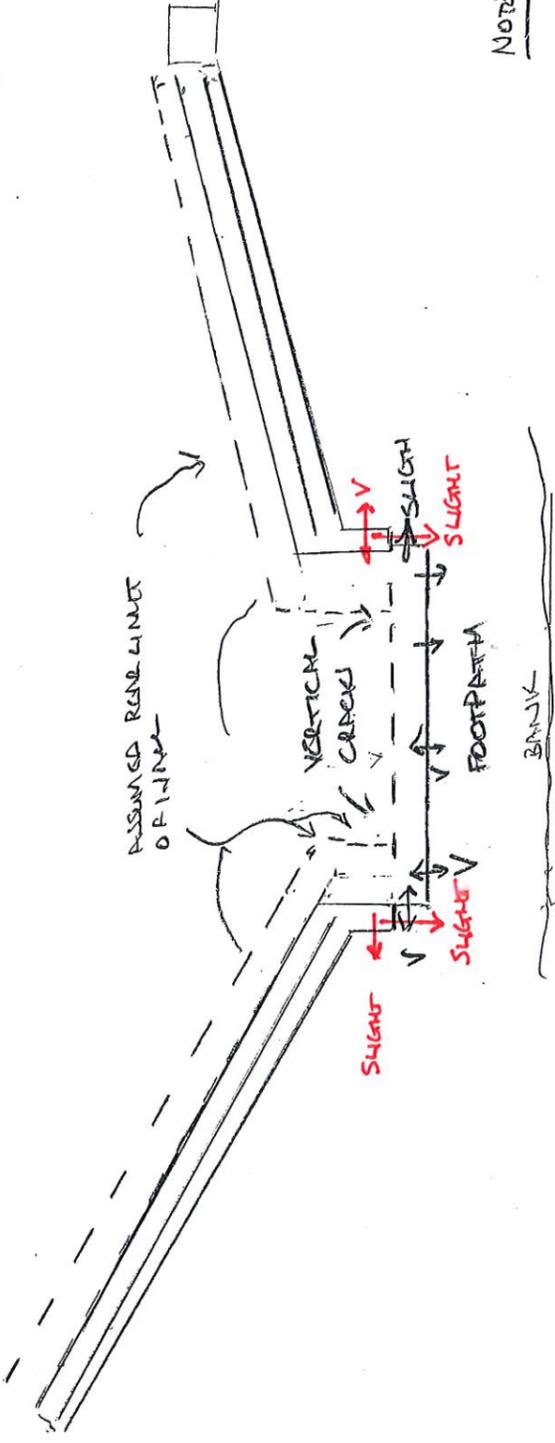
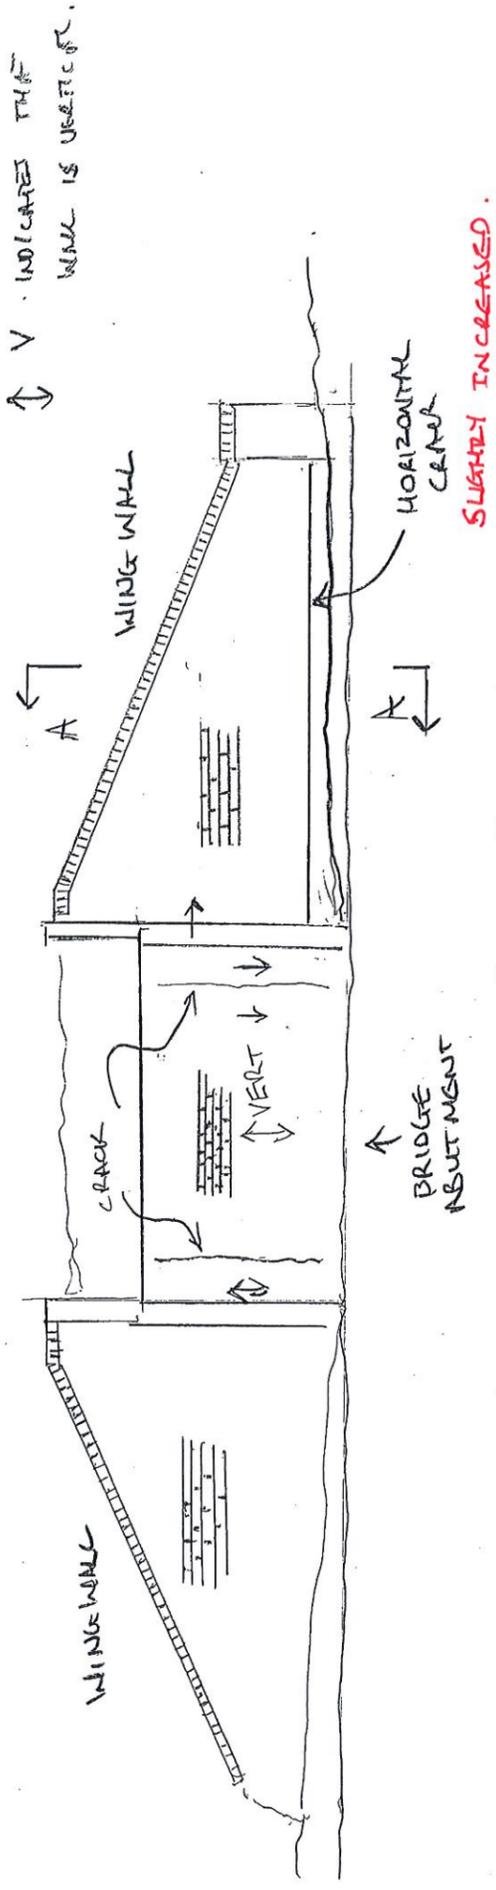
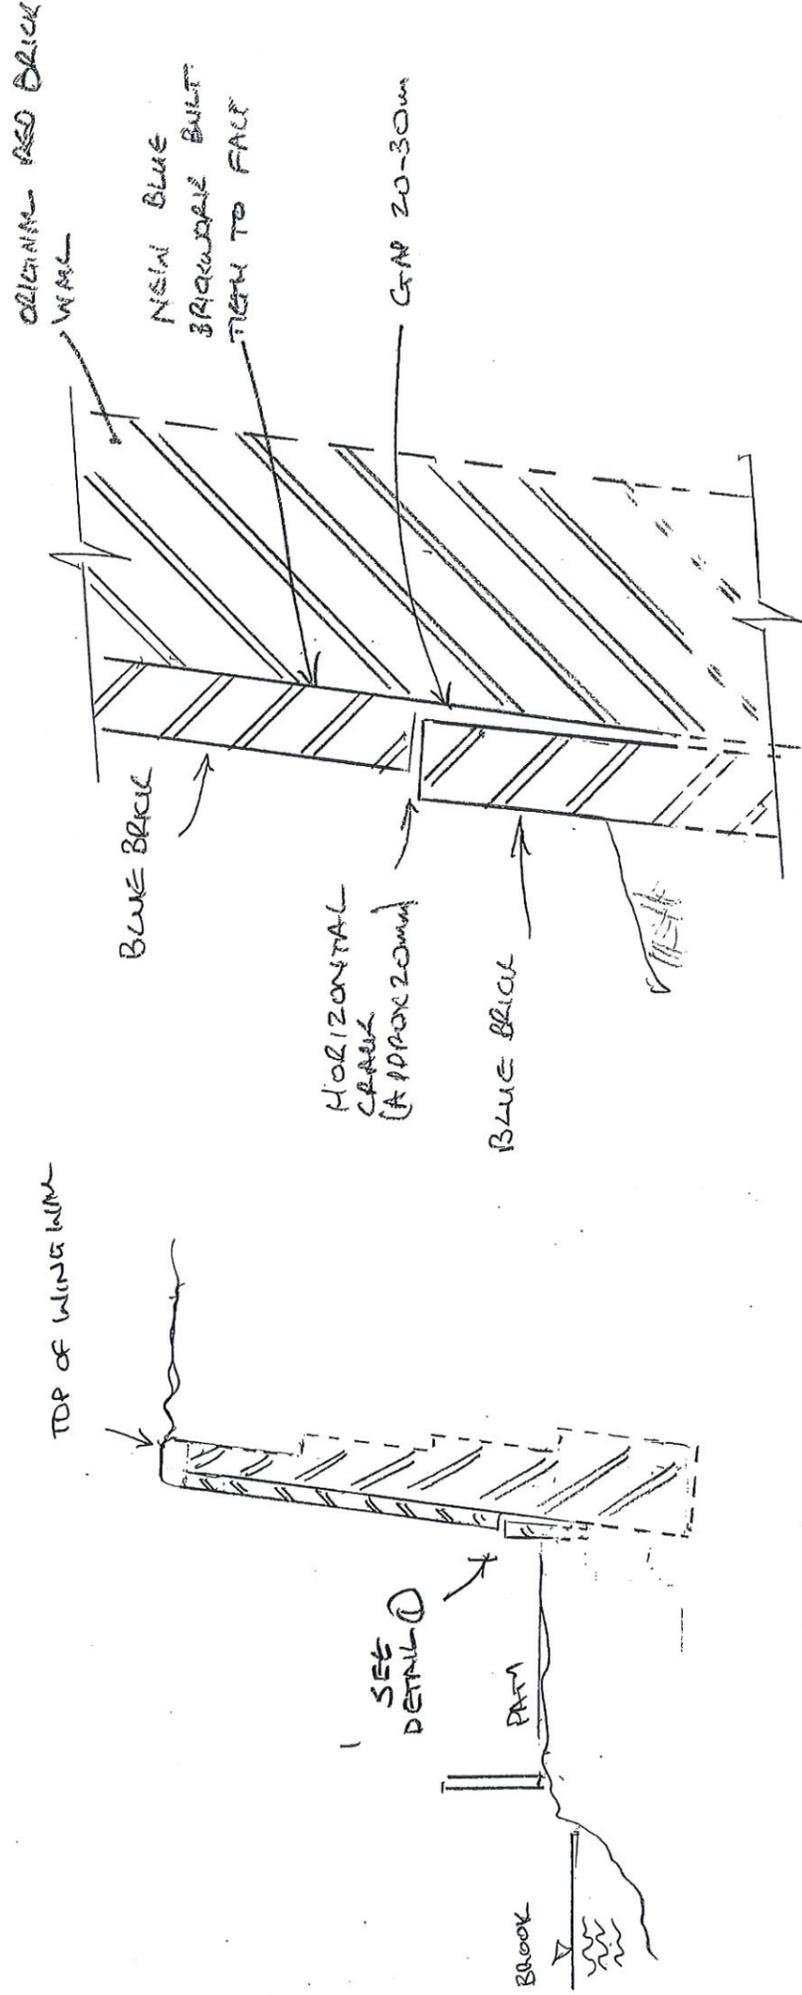
North Wingwall: There is an increase in the width of the long horizontal substantial crack which is present towards the base of this wingwall. This crack is in the brickwork that was added to reface the original wingwall as noted in the 2019 report. A careful inspection of the adhesion of the new facing where it is visible at the top of the abutment shows no indication of slippage of the upper part of this facing and it is thus apparent that it is the base of the additional facing that has sunk further. It was concluded in the 2019 report that the crack was opening up as a result of the facing being inadequately founded, with the upper part of the facing attached to the original wingwall either by mechanical fixing or mortar adhesion.

South Wingwall: There has also been very slight movement of this wingwall at its junctions with the main abutment.

- 2) Wing Wall: the base of the refacing has dropped a little further, presumably due to inadequacy of its foundation. This is clearly shallower and less substantial than the original wingwall – presumably as it was constructed principally for cosmetic purposes. As there is minimal support from the bottom element of this facing to the upper part, this will make no significant alteration to the likelihood of its collapse. Nevertheless, the possibility remains that rapid failure of the facing could occur if the adhesion of the upper part is lost. Such a failure would not lead to overall failure of the wingwall or the abutment but would result of collapse of bricks on to the footpath. This brick facing should be reviewed regularly for signs of more widespread cracking. As noted in the 2019 report, it would be useful to investigate the nature of fixing between the facing and the original brickwork. Mechanical fixing would give a greater degree of comfort that sudden collapse of the facing is unlikely. There appears to have been very slight movement of the wingwall at its junction with the main abutment. As the two elements are reasonably well bonded, it is unlikely that movement here will progress rapidly.

- 3) South Wing Wall: The general condition of the south wingwall remains fair, although there appears to have been slight movement at its junction with the main abutment. As with the north wingwall, the wall is well bonded to the abutment and rapid progress is unlikely.

- 1) It is recommended that periodic observation of the north wing wall is undertaken and that Wellan (or another qualified engineer) is requested to advise immediately, if new cracking appears.
- 2) Further formal review should be undertaken within the next five years.
- 3) The information provided by Wellan Ltd should be retained by Adderbury Parish Council and made available to any future party advising with regard to the bridge abutment or wing walls.
