## Section 19 Flood Investigation Report

Section 19 Flood Investigation Report: Adderbury

Dates of Flood Incidents: 23<sup>rd</sup> September 2024 and 24<sup>th</sup> November 2024

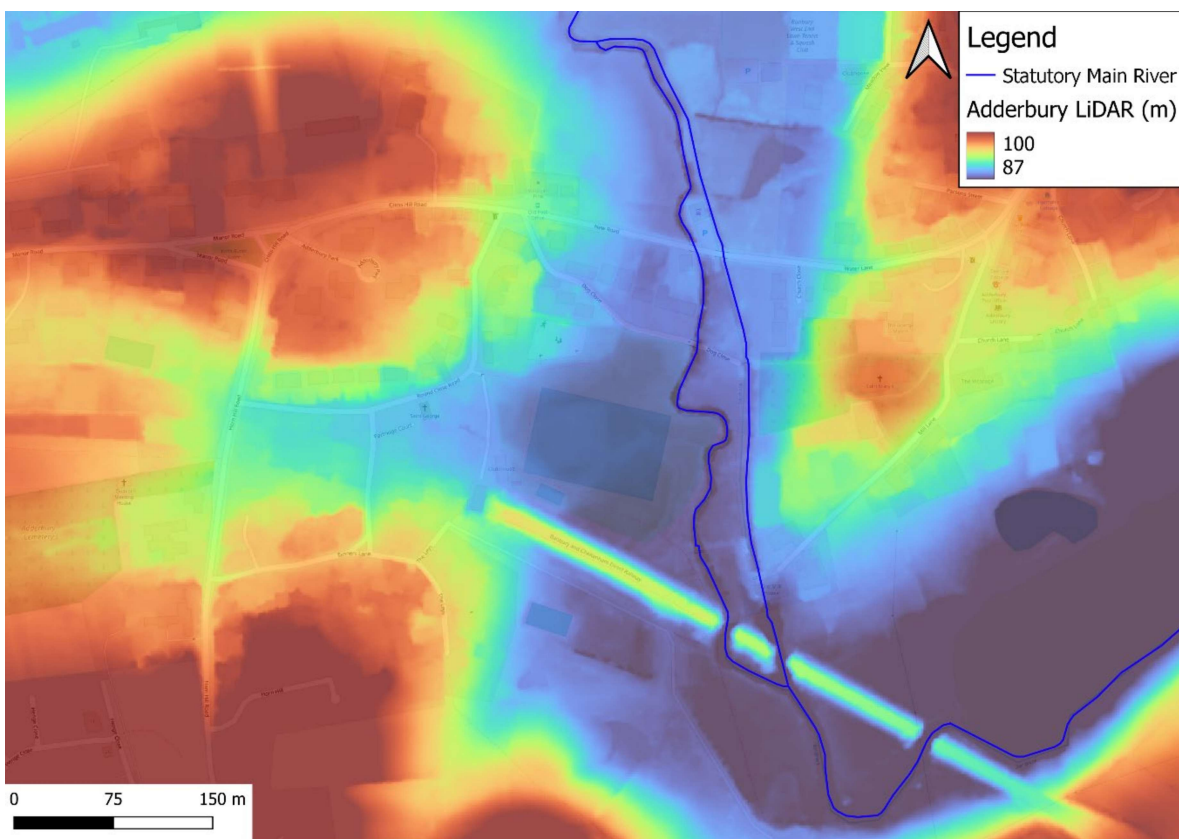
Figure 4 - Area of Interest elevation overview generated by LiDAR (Source: DEFRA 2022), including Statutory Main River of Sor Brook

The Environment Agency's Risk of Flooding from Rivers and the Sea (RoFRS) maps indicate the annual chance of flooding from rivers and the sea, considering the presence and condition of flood defences. The region surrounding the Sor Brook, including the eastern end of Dog Close is classified as being at high risk by the ROFRS map (Figure 6), meaning there is a greater than 3.33% annual exceedance probability (AEP) of flooding. This area also includes a significant portion of the playing fields to the south of Dog Close which has been identified as being at a lower elevation than the surrounding area by the LiDAR imagery (Figure 3 and Figure 4).

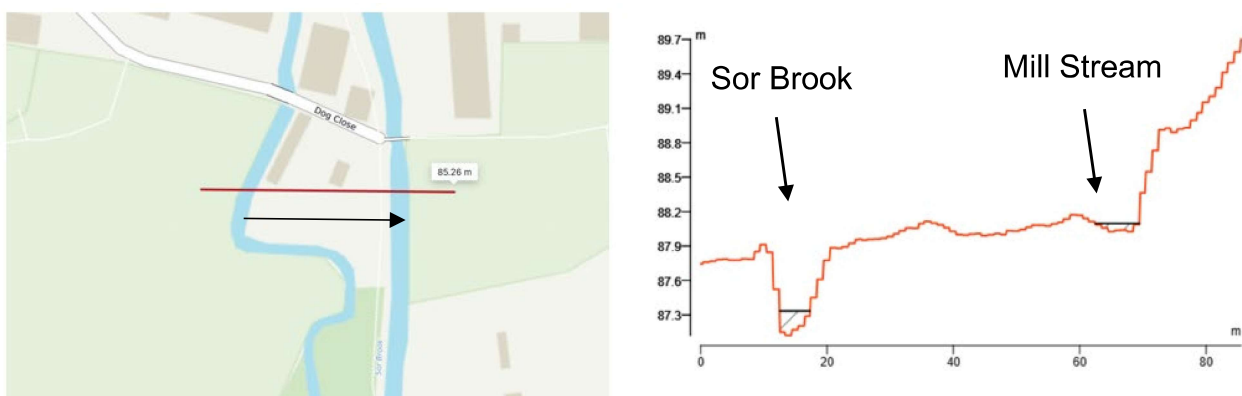
The role of the Mill Stream in the flooding events is also an important consideration. Figure 8 shows the elevation of both channels taken from LiDAR data, which shows the Mill Stream to be perched approximately 1m above the natural elevation of the Sor Brook. The size of the Mill Stream is also much smaller compared to the Sor Brook. Despite this, it is understood from the Environment Agency that the majority of water flows through the Mill Stream meaning that once the capacity is exceeded, flooding is likely to occur through right bank overtopping, submerging the space between the Mill Stream and the Sor Brook as the flood waters seek the lowest part of the floodplain on the playfields.

Figure 8 - Elevation of the Sor Brook in comparison to the Mill Leat. (Source: DEFRA 2025)

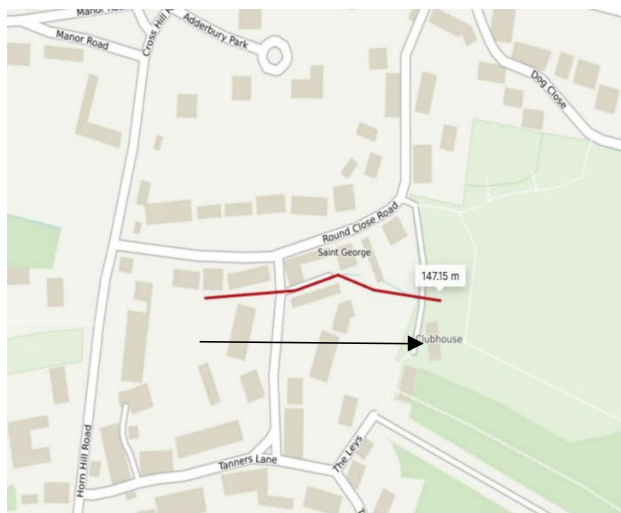
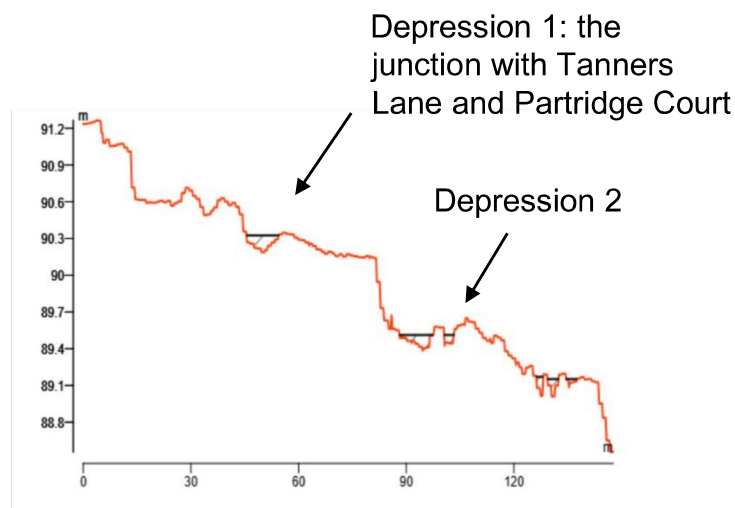
A cross section taken through the region (Figure 10) shows the 0.2m depressions along Partridge Court when compared to the higher surrounding land. Surface water is more likely to pool in these regions, especially in cases where the amount of surface water runoff is substantial.

Figure 10 - Cross section of elevation across Partridge Court indicating localised depressions in land surface. (Source: DEFRA 2025)

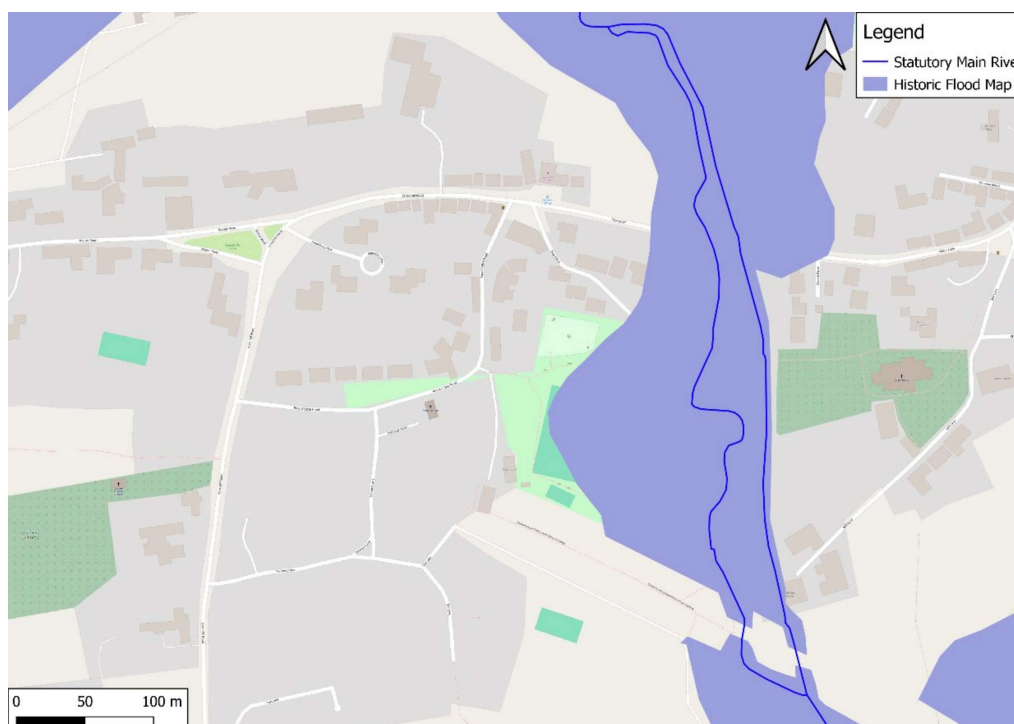
There is limited public data available of previous flood events in Adderbury. Anecdotally, there are reports from residents that flooding occurred in 2007 and 1997/8, with the outlines for the 1998 event mapped in DEFRA's Historic Flood Map (Figure 11). This is a GIS layer showing the maximum extent of individual Historic Flood Outlines from rivers, the sea and groundwater springs that meet a set criteria. It shows areas of land that have previously been subject to flooding in England. This excludes flooding from surface water, except in areas where it is impossible to determine whether the source is fluvial or surface water, but the dominant source is fluvial<sup>1</sup>. The map shows the eastern part of Dog Close to have experienced historical flooding.

Figure 11 – Historic Flood Map of Adderbury (Source: DEFRA 2025)

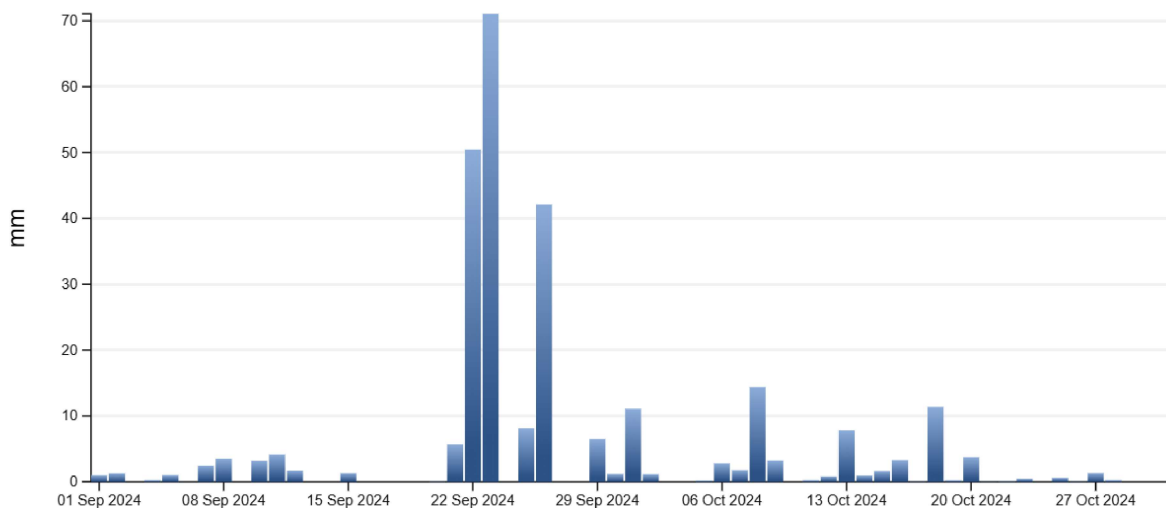
At the Grimsbury (Banbury) rainfall gauge, 6mm, 50mm and 71mm of rain fell on the 21<sup>st</sup>, 22<sup>nd</sup> and 23<sup>rd</sup> of September, respectively (Figure 14). A separate rainfall event on the 26<sup>th</sup> of September followed a few days of little to no rain and will have likely contributed to the flooding period being prolonged. An incredibly high 15-minute maximum of 10mm fell at 16:30 on the 22<sup>nd</sup> of September with 8mm falling at 15:45 on the 26<sup>th</sup> of September. (Figure 15). At the time the daily rainfall total of 71mm on the 23<sup>rd</sup> of September was the third highest ever recorded at the Grimsbury (Banbury) rainfall gauge since records began in May 1989.

Figure 14 - Daily rainfall at the Grimsbury (Banbury) Gauge throughout September and October 2024. (Source: DEFRA 2025).

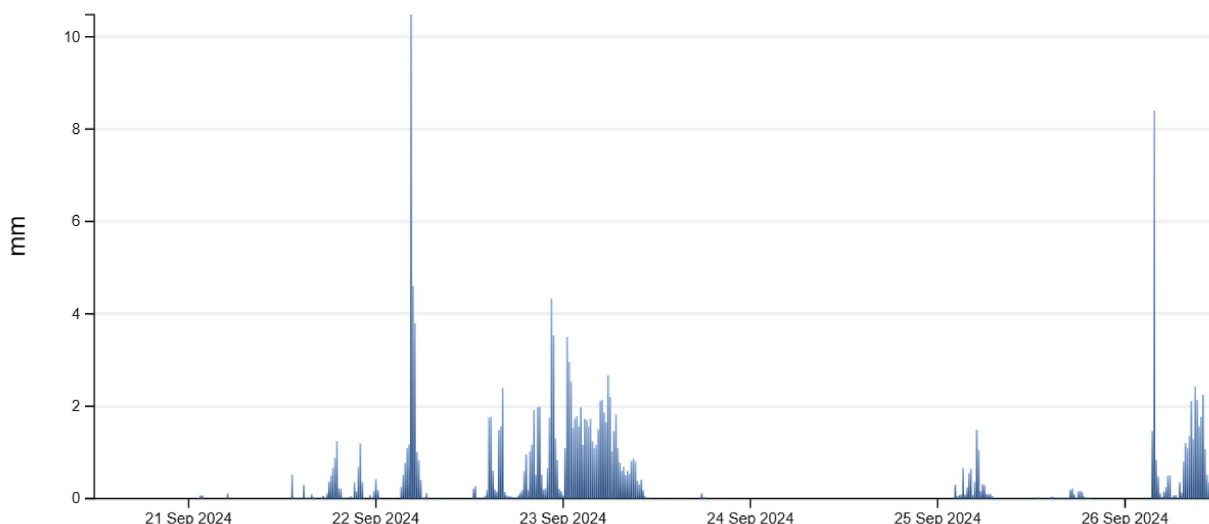
Figure 15 - Rainfall over 15-minute intervals at the Grimsbury (Banbury) Rainfall Gauge between 21-26<sup>th</sup> September 2024. (Source: [DEFRA 2025](#)).

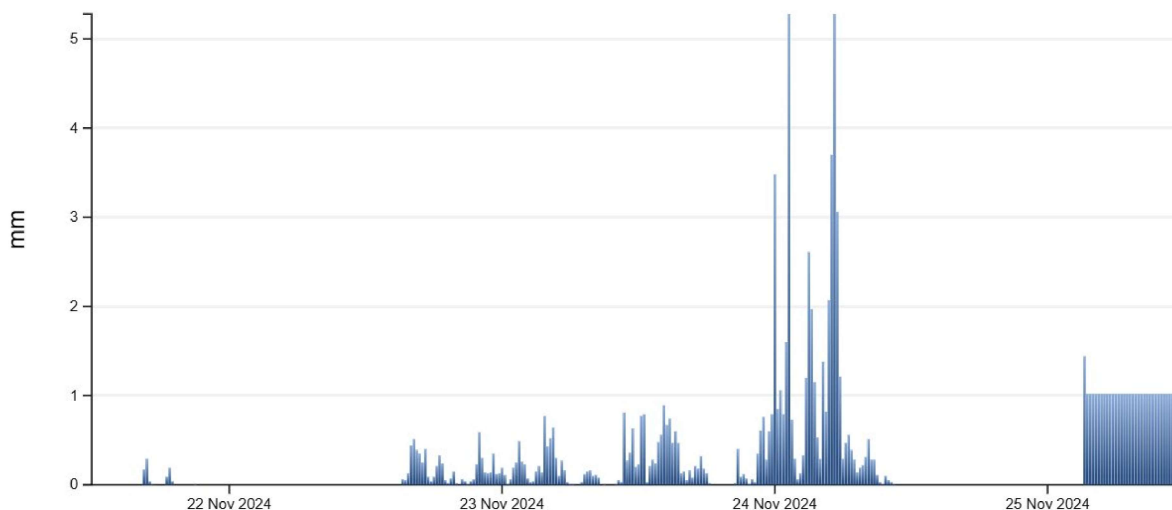
At the Grimsbury (Banbury) rainfall gauge 21mm and 48mm fell on the 23<sup>rd</sup> and 24<sup>th</sup> of November respectively. It should be noted that the data shown after the 25<sup>th</sup> November is anomalous and should be discounted. Indeed, the data presented on the DEFRA hydrology explorer website from this point until the 3<sup>rd</sup> December 2024 are all unconfirmed and appear to be anomalous and should not be considered as reliable

until checked by DEFRA. A 15 minute rainfall peak 5mm occurred twice on the 24<sup>th</sup> of September, the first being at 13:15 and the second being at 17:15.

Figure 17 - Rainfall over 15-minute intervals at the Grimsbury (Banbury) Rainfall Gauge between 22-24<sup>th</sup> November 2024. Note that the data displayed after the 25<sup>th</sup> of November are anomalous and should be discounted. (Source: [DEFRA 2025](#)).

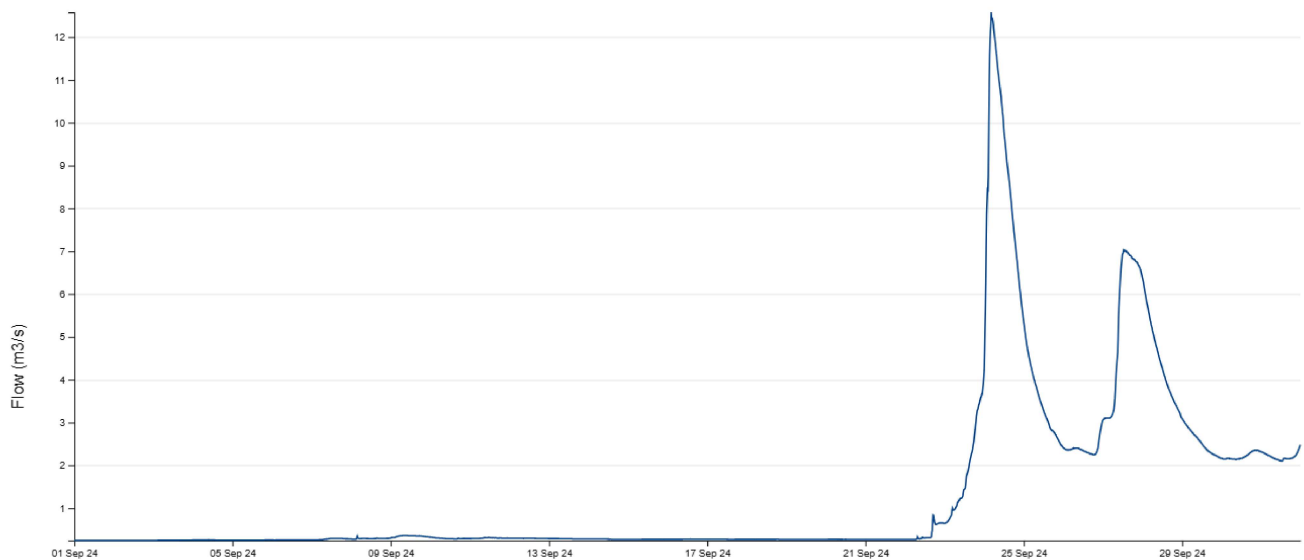
The response in river flow following the rainfall events seen in late September 2024 is shown in Figure 18. Flow in the Sor Brook spiked dramatically, mirroring the rainfall in Figure 14 and Figure 15. This supports the contention that incredibly heavy rainfall in the region and towards Sor Brook was the overwhelming cause of the channel capacity being overwhelmed. The rainfall was also prolonged at an extent that didn't allow the river levels to recede.

River flow in the Sor Brook spiked from  $0.3\text{m}^3\text{s}^{-1}$  on the 21<sup>st</sup> of September, to a maximum flow of  $12.6\text{m}^3\text{s}^{-1}$  on the 24<sup>th</sup> of September (the daily average on 24<sup>th</sup> September was  $6.7\text{m}^3\text{s}^{-1}$ ). River flow then receded towards the end of the month, except for some less dramatic and brief rises in level following the rain associated with the remaining 2 low pressure systems in September.

Figure 18 –Flow levels in Sor Brook at Bodicote prior to, during and following the flood event – maximum level peaking at  $12.58\text{m}^3\text{s}^{-1}$  on the 24<sup>th</sup> of September 2024. (Source: [DEFRA 2025](#)).

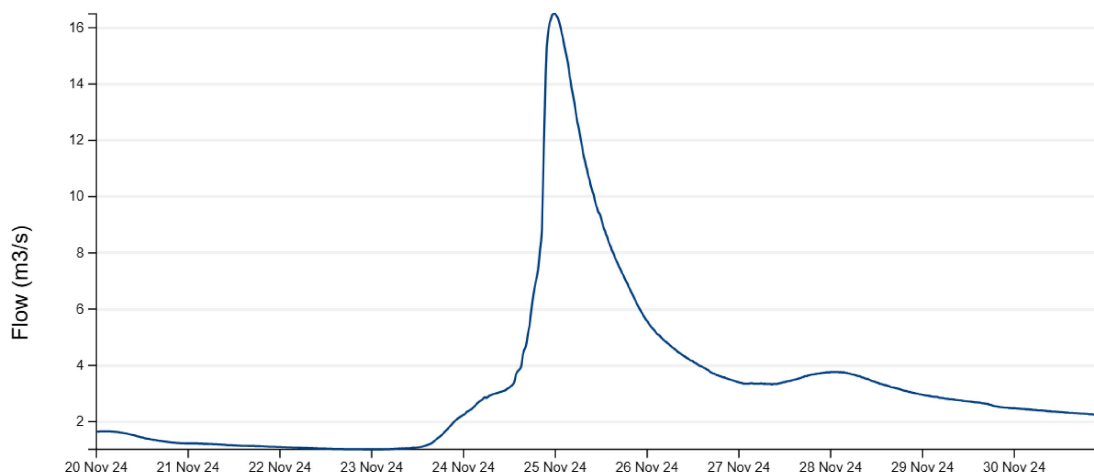
The Bodicote flow gauge (Figure 19) spiked following the November rainfall event shown in Figure 19. Despite the amount of rainfall that fell during the November 2024 event being lower than during the September 2024 event, the peak flow of  $16.46\text{m}^3\text{m}^{-1}$  was greater. The flow also peaked in a single event without prolonged rainfall. As such, the flooding experienced in November is likely to have come as a result of a combination of intense rainfall combined with an already saturated catchment from the September rainfall. This differs from the multi peaked event in September, caused by a series of low pressure systems that led to the catchment remaining ‘topped up’ over the course of multiple days.

Figure 19 - Flow levels in Sor Brook at Bodicote prior to, during and following the flood event – maximum level peaking at  $16.5\text{m}^3\text{s}^{-1}$  on the 24<sup>th</sup> of November 2024 at 23:30. (Source: [DEFRA 2025](#)).

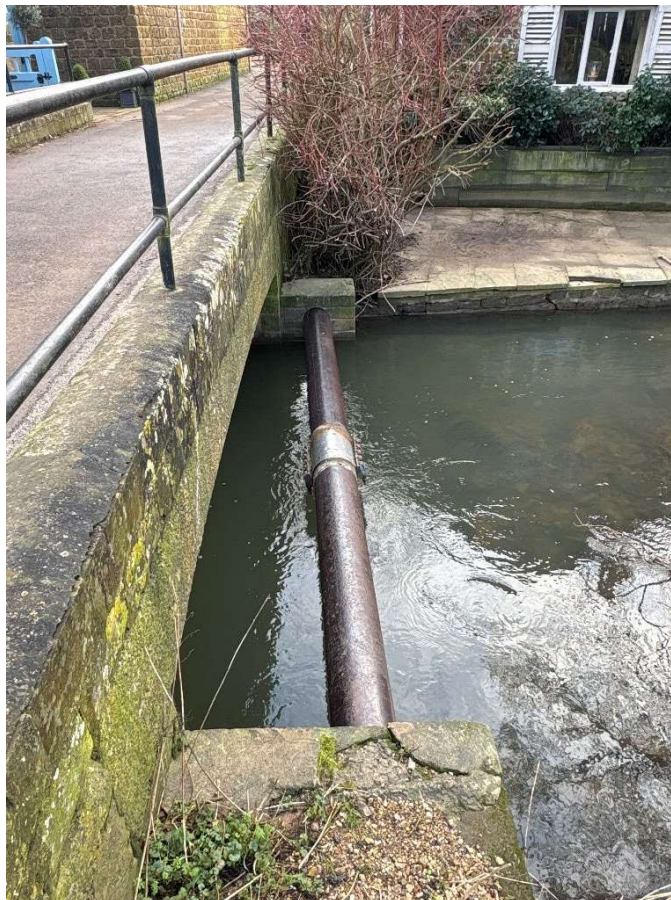
A Thames Water pipe on the downstream side of Dog Close bridge was inspected by the site team. The pipe, which is shown in Figure 20, is set quite low into the channel. The size of the pipe is quite small however and would be unlikely to have a major impact on channel capacity. The pipe poses more of an issue in its potential to trap debris and cause blockage in the channel from materials such as gravel, branches, wood or other debris like fences etc that are collected by the river during high flow events. It is essential that the channel around this pipe is maintained and kept free of debris.

*Figure 20 – Thames Water pipe along Sor Brook on downstream side of the Dog Close bridge. (Source: Site visit Jan 2025)*

Thames Water to consider the viability of options for adjusting the position of their pipe on the downstream side of Dog Close Bridge to reduce the risk of debris blocking the bridge and channel.	Thames Water	CDC, OCC LLFA
Thames Water to conduct ongoing and regular maintenance of Thames Water assets. This could involve regular checks for blockages in the system, considering repairs to any damaged structures to reduce the risk of surcharge and identifying area parts of their network that may be undercapacity.	Thames Water	
CDC and the Partridge Court landowner to explore the feasibility of formalising a flow route from Partridge Court car park to the open ditch behind the properties in Round Close Road, to alleviate the ponding of water in Partridge Court car park.	CDC Partridge Court landowner	OCC LLFA Parish Council
OCC LLFA to explore the spring flows emerging from the north side of Round Close Road and possible ways to formalise the routing of these flows into the drainage network.	OCC LLFA	OCC Highways, CDC

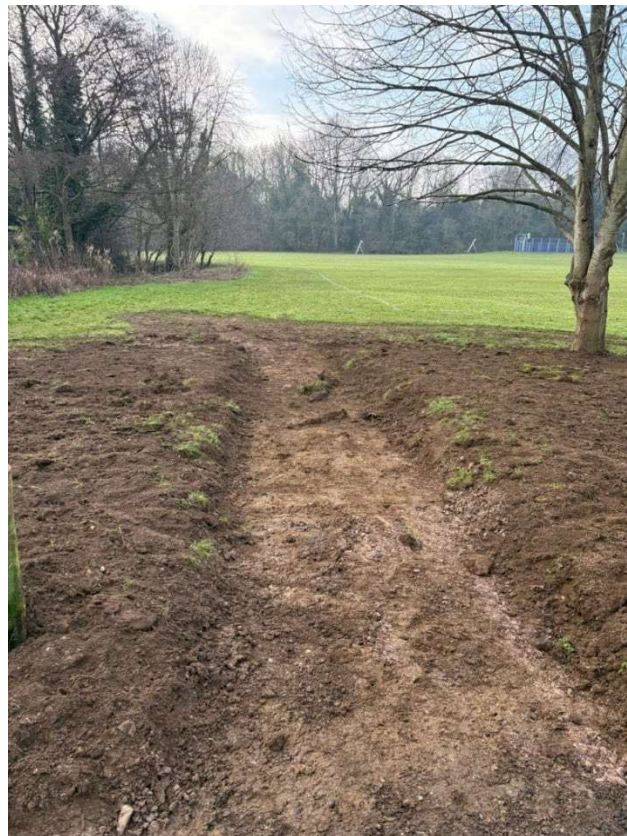
On the day of the site visit, OCC had constructed a slipway to try to relieve pooling water from Dog Close to drain back into the Sor Brook (Figure 21). An additional channel started at the raised elevation south of Dog Close will provide extra capacity in the region but will also facilitate the drainage of Dog Close such that water has less time to collect and pool. The additional channel may also encourage the flood water to flow towards the floodplain centred around the playing fields rather than the properties upstream.

*Figure 21 - Slipway being cut along field adjacent to Dog Close to allow water to drain back into the channel more quickly. (Source: Site visit Jan 2025)*

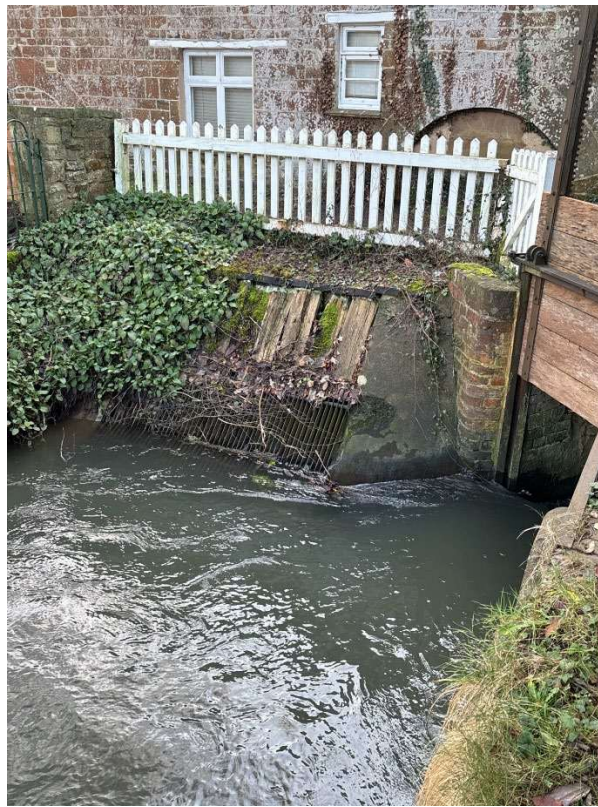
The site team also inspected the mill channel (Figure 22) which goes under the Old Mill House. This original route for the Mill Stream is now blocked off. Water is now funnelled down a small side sluice causing a significant flow restriction. During the flood events water was observed to back up from here which may have contributed to the retention of water in the flooded regions during the events detailed by this report.

*Figure 22 – Disused Mill channel and side sluice diverting flow back into the Sor Brook. (Source: Site visit Jan 2025)*
